## Product / EUT Details

Product Name	RADO
Product ID	2735
Test Location	K-LITE Testing Laboratory
Report Date	21/05/21
Reference Sl. No.	RADO/105/IKT1104

## (IK TEST) – Conforming to IEC 60598-1

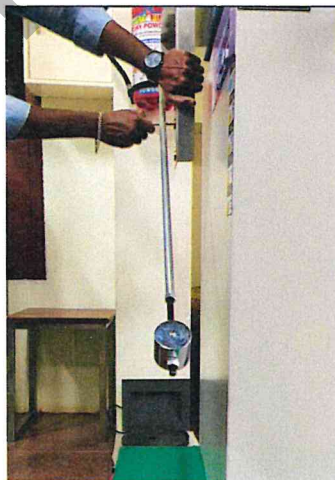
Test Equipment	IK PENDULUM HAMMER / BALL DROP TEST(Refer figure below)
Test Procedure	IK08
Impact Energy (J)	5J
Test Date	21/05/21
No of Impact	3
Drop Height	300mm

Requirement	Results	Remarks
EUT should not have any visual damage and shall work in normal condition after the impact test.	<ul style="list-style-type: none"> <li>- No visible damage was observed on the EUT after completion of the mechanical impact test.</li> <li>- EUT was working in normal condition after the impact test.</li> <li>- Therefore the EUT met the requirement of IK.</li> </ul>	P
P→ Passed (Meets requirement); F→ Failed (Does not meet requirement); NA→ Limits of Performance Not Applicable.

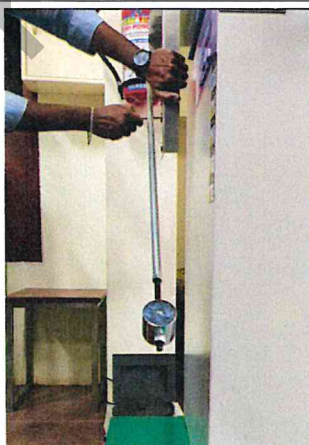
Test Equipment	IK PENDULUM HAMMER / BALL DROP TEST(Refer figure below)
Test Procedure	IK08
Impact Energy (J)	5J
Test Date	20/05/21
No of Impact	3
Drop Height	300mm

Requirement	Results	Remarks
EUT should not have any visual damage and shall work in normal condition after the impact test.	<ul style="list-style-type: none"> <li>- No visible damage was observed on the EUT after completion of the mechanical impact test.</li> <li>- EUT was working in normal condition after the impact test.</li> <li>- Therefore the EUT met the requirement of IK.</li> </ul>	P
P→ Passed (Meets requirement); F→ Failed (Does not meet requirement); NA→ Limits of Performance Not Applicable.
