<b>K-LITE</b>	<b>IMPACT RESISTANCE TEST REPORT</b>	Doc. No. KL/LAB/IKT1080
		Rev. No. 00

Product Name	SUDO MINI – VERTICAL REEDED
Product ID	2750
Test Location	K-LITE Testing Laboratory
Report Date	20/05/21
Reference Sl. No.	SUDO MINI – VERTICAL REEDED/081/IKT1080

**(IK TEST) – Conforming to IEC 60598-1**

Product Name	SUDO – ASY VERTICAL REEDED
Product ID	2763
Test Location	K-LITE Testing Laboratory
Report Date	21/05/21
Reference Sl. No.	SUDO – ASY VERTICAL REEDED/094/IKT1093

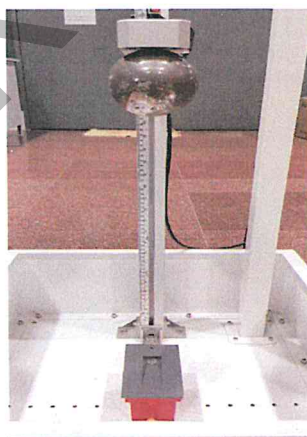
Test Equipment	IK PENDULUM HAMMER / BALL DROP TEST(Refer figure below)
Test Procedure	IK09
Impact Energy (J)	10J
Test Date	20/05/21
No of Impact	3
Drop Height	200mm

Requirement	Results	Remarks
EUT should not have any visual damage and shall work in normal condition after the impact test.	<ul style="list-style-type: none"> <li>- No visible damage was observed on the EUT after completion of the mechanical impact test.</li> <li>- EUT was working in normal condition after the impact test.</li> <li>- Therefore the EUT met the requirement of IK.</li> </ul>	P
P→ Passed (Meets requirement); F→ Failed (Does not meet requirement); NA→ Limits of Performance Not Applicable.

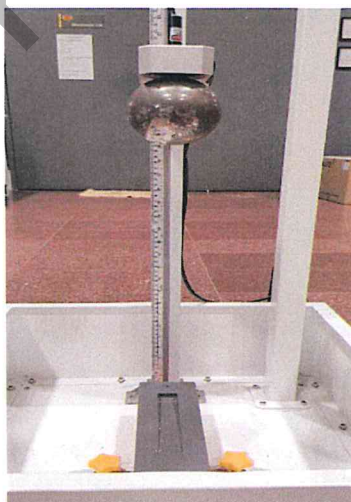
Test Equipment	IK PENDULUM HAMMER / BALL DROP TEST(Refer figure below)
Test Procedure	IK09
Impact Energy (J)	10J
Test Date	21/05/21
No of Impact	3
Drop Height	200mm

Requirement	Results	Remarks
EUT should not have any visual damage and shall work in normal condition after the impact test.	<ul style="list-style-type: none"> <li>- No visible damage was observed on the EUT after completion of the mechanical impact test.</li> <li>- EUT was working in normal condition after the impact test.</li> <li>- Therefore the EUT met the requirement of IK.</li> </ul>	P
P→ Passed (Meets requirement); F→ Failed (Does not meet requirement); NA→ Limits of Performance Not Applicable.
