| <b>K-LITE</b> | <b>IMPACT RESISTANCE TEST REPORT</b> | Doc. No. KL/LAB/IKT1149 |

| Product Name | SUDO - OPEN |

**(IK TEST) – Conforming to IEC 60598-1**

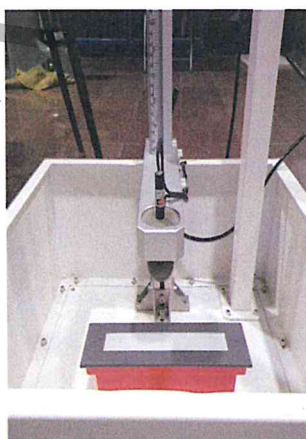
| Test Equipment | IK PENDULUM HAMMER / BALL DROP TEST(Refer figure below) |
| Drop Height | 140mm |

| Requirement | Results | Remarks |
|---|---|---|
| EUT should not have any visual damage and shall work in normal condition after the impact test. | <ul style="list-style-type: none"> <li>- No visible damage was observed on the EUT after completion of the mechanical impact test.</li> <li>- EUT was working in normal condition after the impact test.</li> <li>- Therefore the EUT met the requirement of IK.</li> </ul> | P |

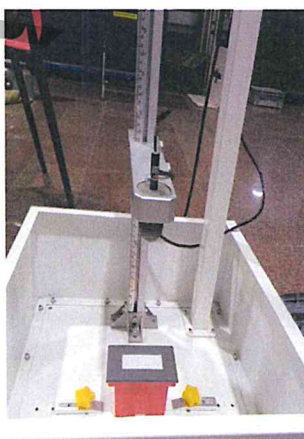
| Test Equipment | IK PENDULUM HAMMER / BALL DROP TEST(Refer figure below) |
| Drop Height | 140mm |

| Requirement | Results | Remarks |
|---|---|---|
| EUT should not have any visual damage and shall work in normal condition after the impact test. | <ul style="list-style-type: none"> <li>- No visible damage was observed on the EUT after completion of the mechanical impact test.</li> <li>- EUT was working in normal condition after the impact test.</li> <li>- Therefore the EUT met the requirement of IK.</li> </ul> | P |

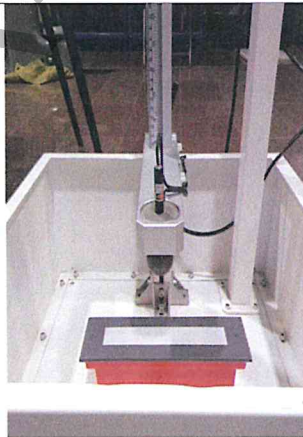
| Test Equipment | IK PENDULUM HAMMER / BALL DROP TEST(Refer figure below) |
| Drop Height | 140mm |

| Requirement | Results | Remarks |
|---|---|---|
| EUT should not have any visual damage and shall work in normal condition after the impact test. | <ul style="list-style-type: none"> <li>- No visible damage was observed on the EUT after completion of the mechanical impact test.</li> <li>- EUT was working in normal condition after the impact test.</li> <li>- Therefore the EUT met the requirement of IK.</li> </ul> | P |
